Eelgrass

Progress Towards the Target

What Is This Indicator?

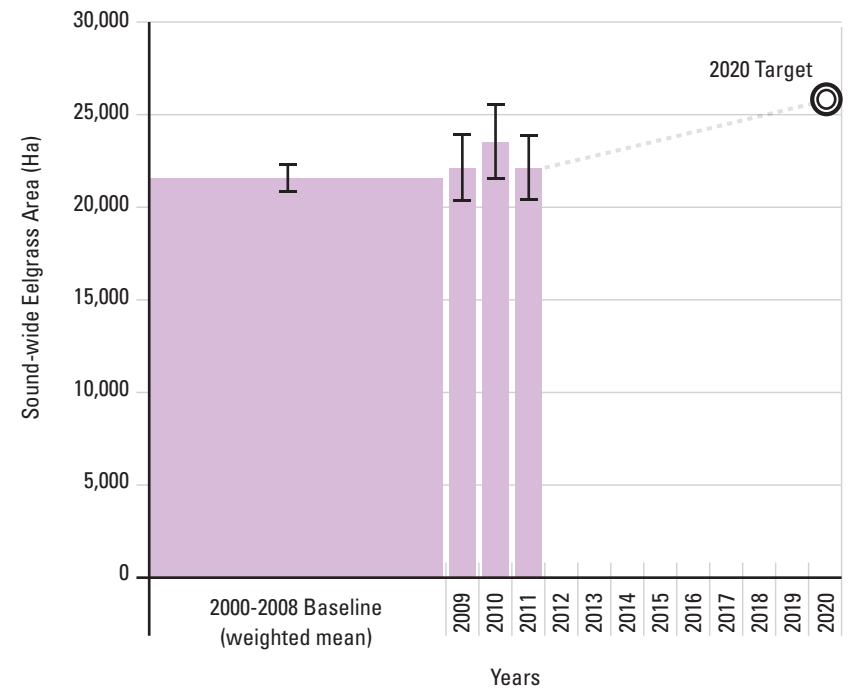
Acres of Eelgrass in Puget Sound

in thousands, 2000-2008 baseline and 2009-2011 annual data

Figure 1. The annual estimates of Sound-wide eelgrass area for 2009-2011 compared to the baseline established by the Partnership's 2020 target for eelgrass recovery. Mean \pm standard error are shown.

Puget Sound supports roughly 22,600 hectares of eelgrass beds (Figure 1). Eelgrass distribution patterns vary by sub-basin, with two main types of eelgrass beds: narrow fringing beds and broad beds on shallow flats. Approximately 25% of the total eelgrass area occurs in only two embayments: Padilla and Samish Bays.

There was no significant increasing or decreasing trend in eelgrass area in 2011 relative to the 2000-2008 baseline, calculated as the weighted mean of eelgrass area in that time period (Figure 1).

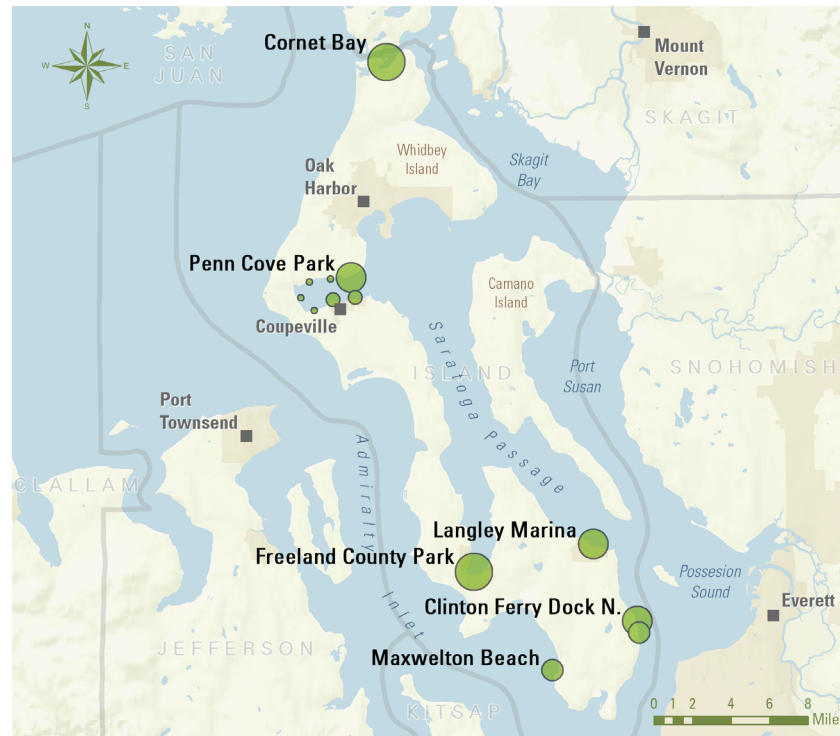
WSU Extension Island County Beach Watchers

2010 - 2011 Eelgrass Surveys

Estimated Bed Area (Acres)

Surveys in 2009 and 2010 confirmed extensive eelgrass beds in Cornet Bay and Holmes Harbor. Damage to eelgrass beds was documented in Cornet Bay with the patterns suggesting possible damage from boating activities. Penn Cove surveys showed relatively few eelgrass beds with an unusual number of green sea urchins. Three years of study in Holmes Harbor point to eelgrass return and relatively stable beds since 2007 and suggest an unusual 2006-2007 winter storm from the north that coincided with an extreme low tide may have influenced the 2007 losses. Data from the eelgrass monitoring project are provided to DNR and are available on the Island County Marine Resource Committee's Sound IQ data system (www.iqmap.org/icSound-IQ/). These data on eelgrass, combined with other data on birds and mammals, intertidal habitats, fish distribution, and more are contributing to the overall understanding of the nearshore ecosystem around Whidbey Island.
